# Lower Colorado River Multi-Species Conservation Program

## Beal Lake Conservation Area

## 2018 Annual Report

**February 2020**

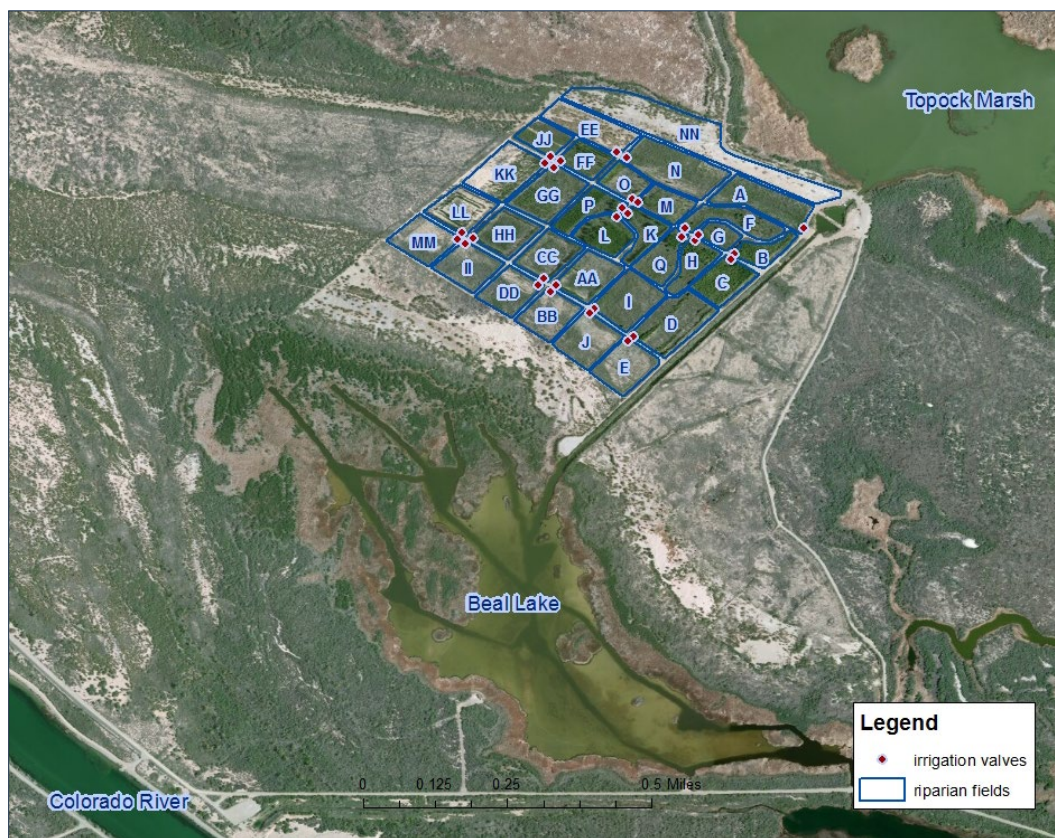
Figure 3.—Overview of the BLCA.

The fields at the BLCA are independently flood irrigated from one alfalfa valve positioned in a corner of each field (figure 3). The fields are irrigated on a schedule that prioritizes establishing newly planted vegetation when applicable, creating microclimate conditions for LCR MSCP species, and preventing salts from accumulating in the soil. The fields recently planted or seeded with native vegetation are irrigated on a weekly basis, while fields with established stands of trees are either frequently irrigated to create microclimate conditions for covered species or are put on a reduced irrigation schedule to merely keep salts from accumulating in the soil.
